Chichester District Council

Heritage At Risk Register

Bedham Mission Church & School **BEDHAM**

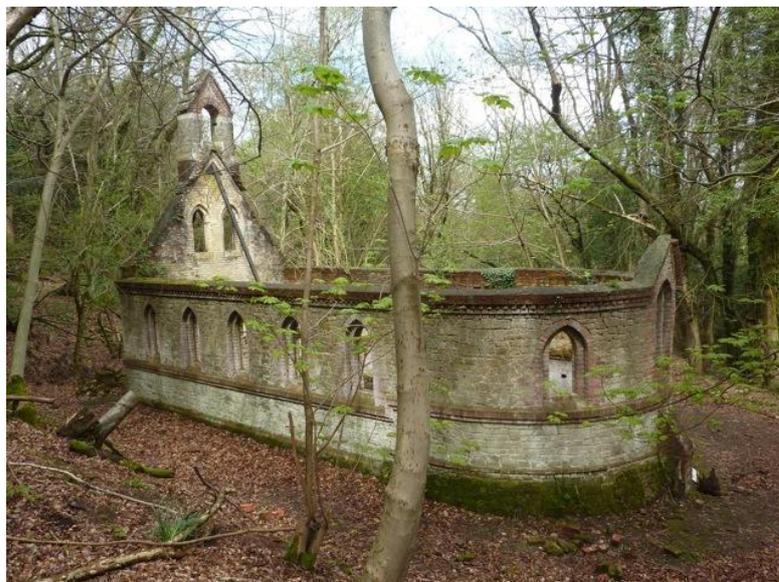
Photograph 2012

Asset Type:	Unlisted Building
Grid Reference:	501604, 121988
Parish:	Bedham
Conservation Area:	No
SDNP:	Yes
Description:	1880 single-cell nonconformist chapel/school built by William Townley Mitford MP of Pitshill.
Priority:	C
Reason for Risk:	General deterioration.
Registered:	
Last Assessed:	19 April 2012
Ownership:	
Current Status:	Derelict building without roof. Internal floor missing. 1 window remains (without glass). External stone and brick skin in reasonable condition, though requires repointing, particularly along the south-west elevation. Internal brick spalling on upper part of walls in places. Excessive loss of lime mortar within. Walls are capped. Metal shoring to north west wall.
