Historic England

Traditional Windows

Their Care, Repair and Upgrading

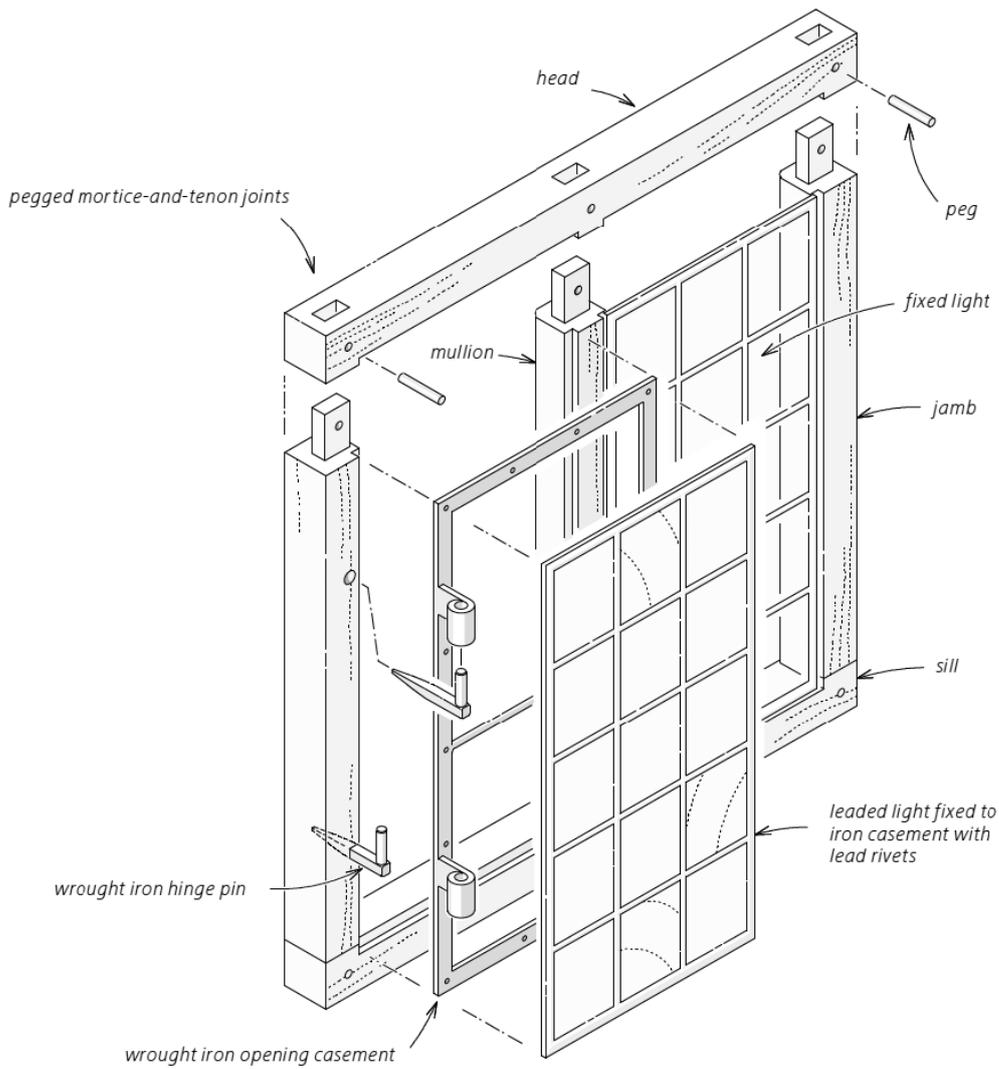
Image 32

A. Typical oak-framed casement window with leaded lights.

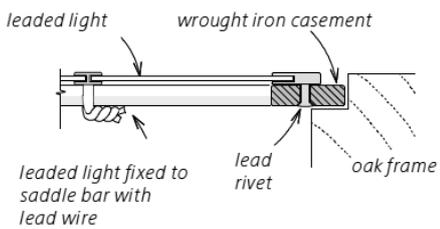
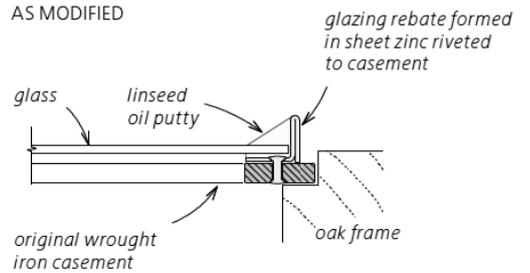
When larger panes of glass became available, leaded lights were often replaced, as shown here.

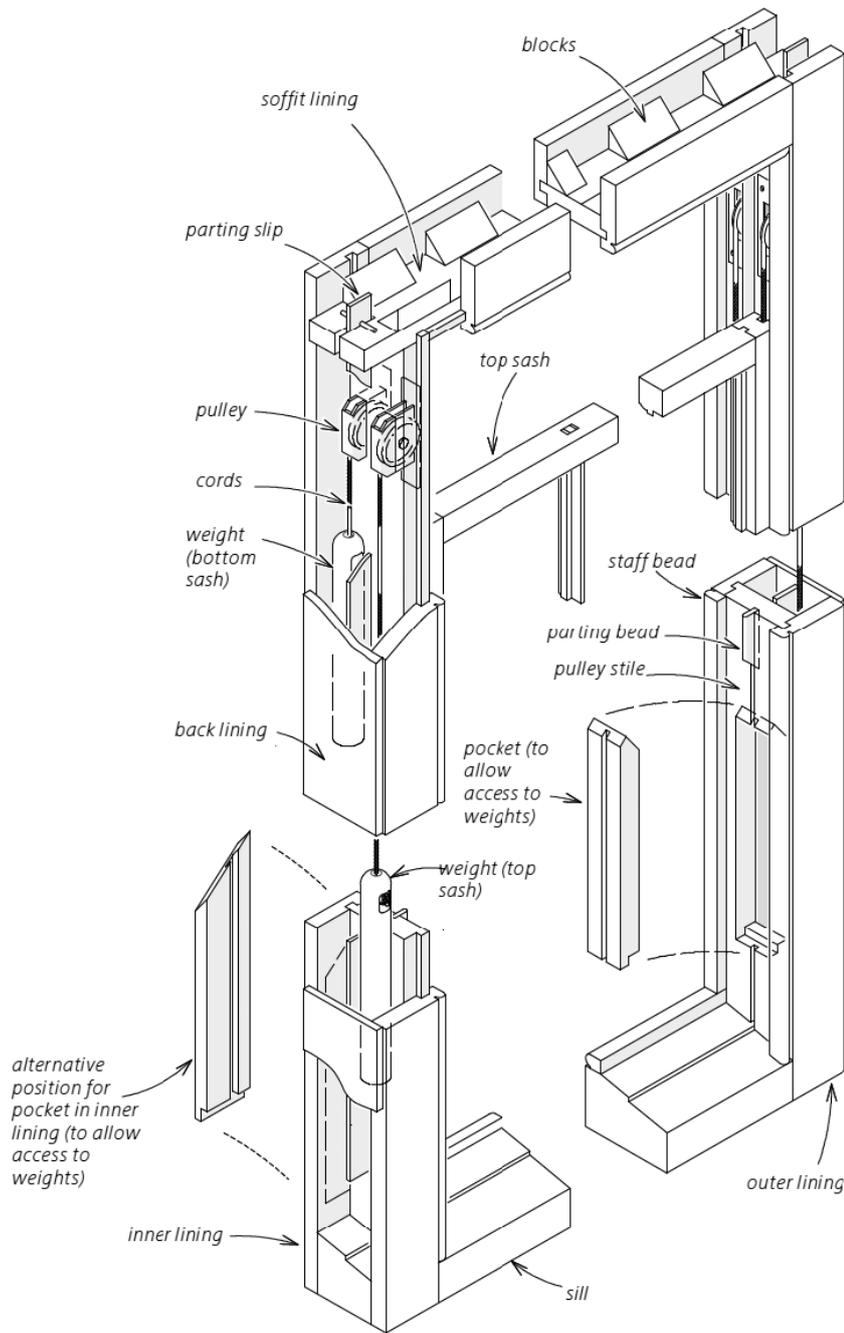
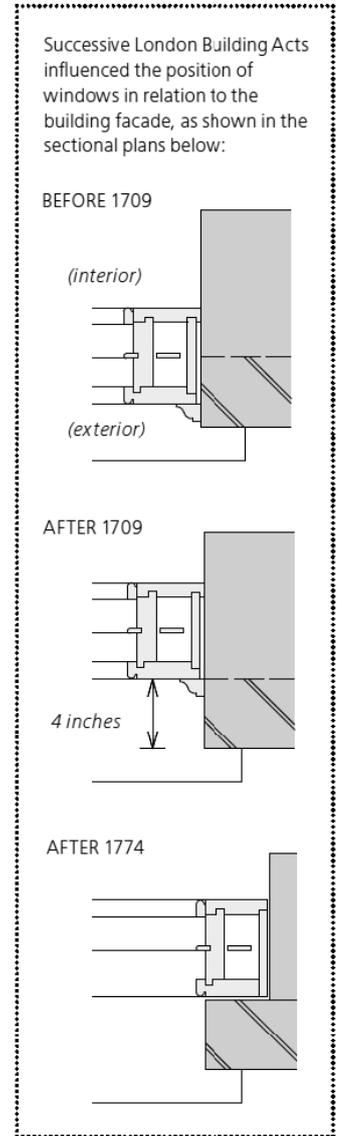
Image 36

Typical details of sliding sash window with cased frame

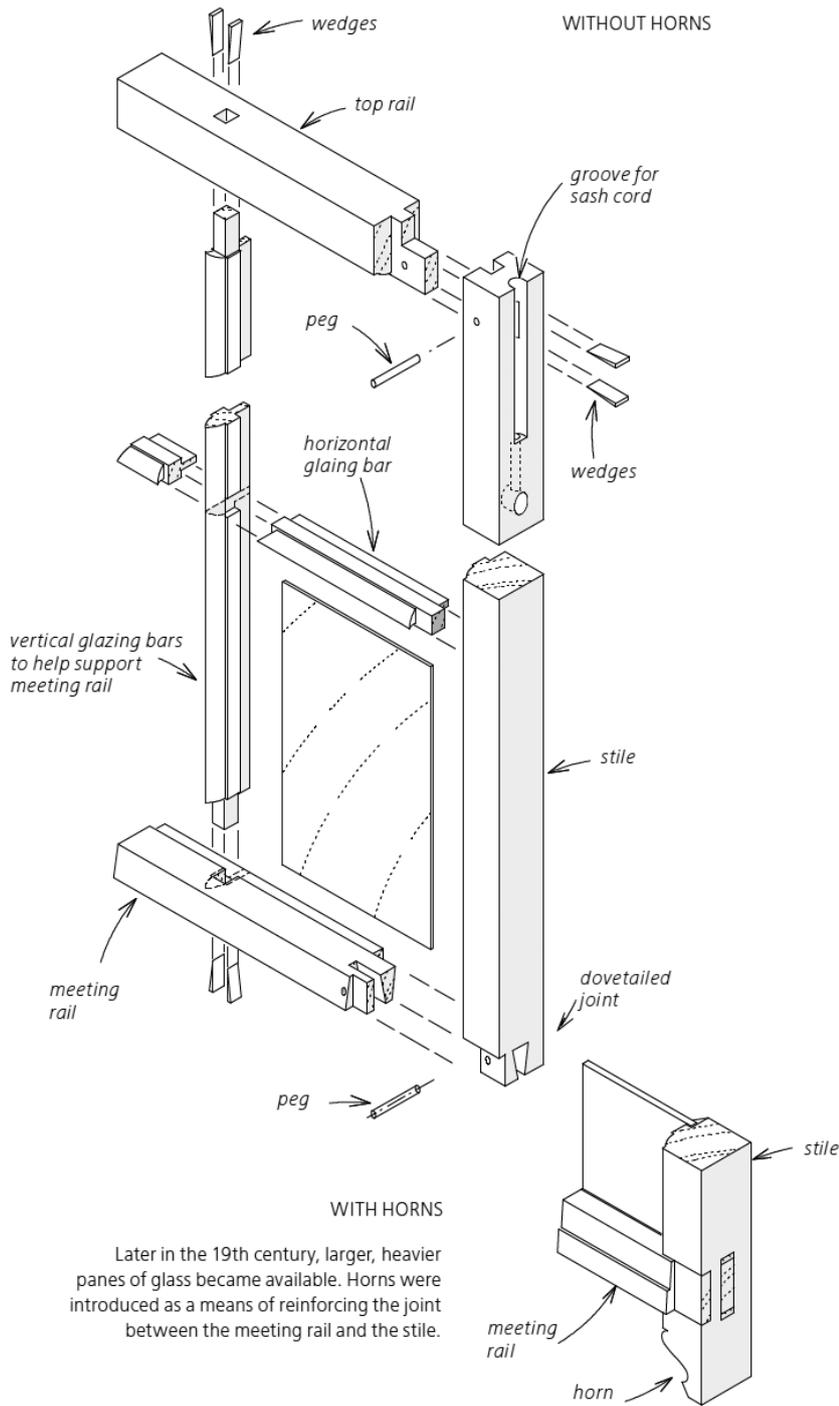
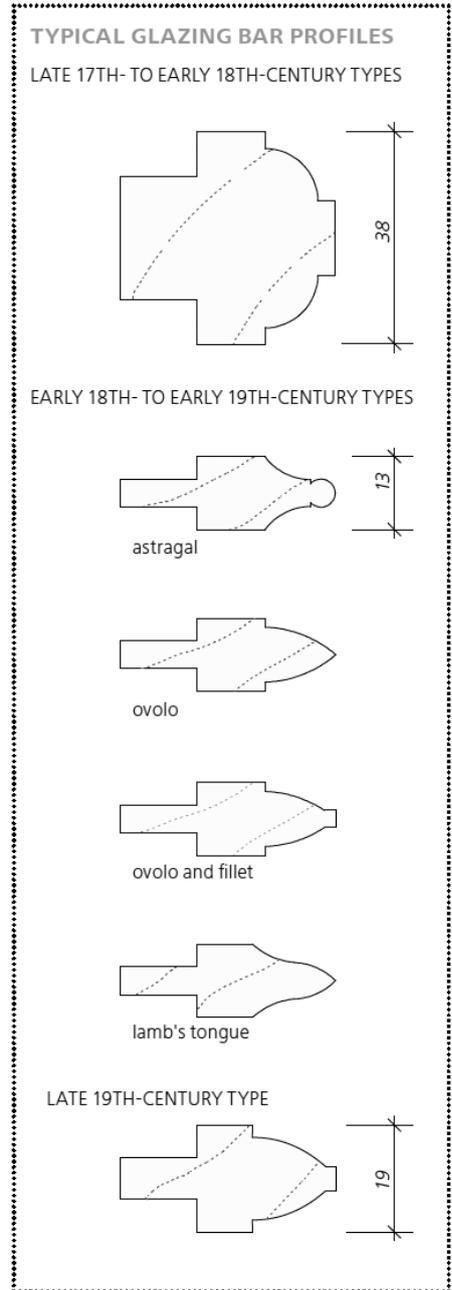
Image 37

A. Sliding sash windows: typical top sash

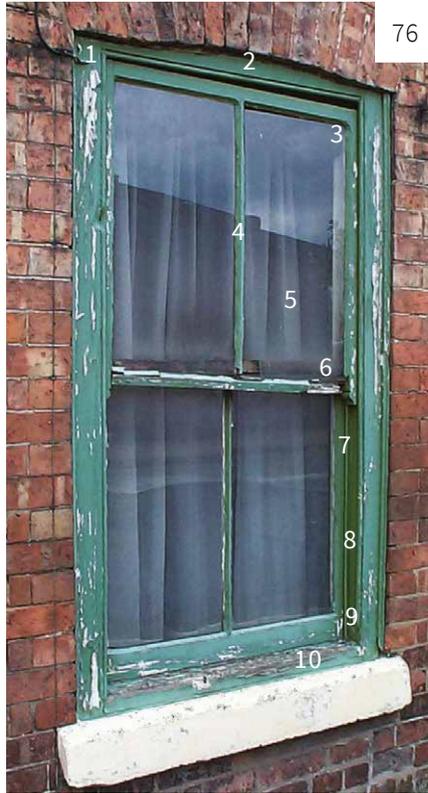
76

1. Holes drilled in frame for cable entry may admit water and cause decay
2. Deformation of window caused by structural movement in wall; sashes no longer fit or slide properly
3. Broken sash cords
4. Breakdown of paint and putty caused by lack of regular maintenance; this allows water to penetrate and become trapped, causing decay
5. Glass displaced or broken due to deformation of sash
6. Failure of joints, caused by timber decay due to water penetration
7. Opening parts of window jammed due to accumulation of paint
8. Worn or damaged beads, causing rattles and draughts
9. Decay of stile (or jamb) and outer lining at junction with sill due to water penetration
10. Decay of sill caused by water penetration after breakdown of paint. Water may also creep into the joint between the timber sill and the masonry sub-sill

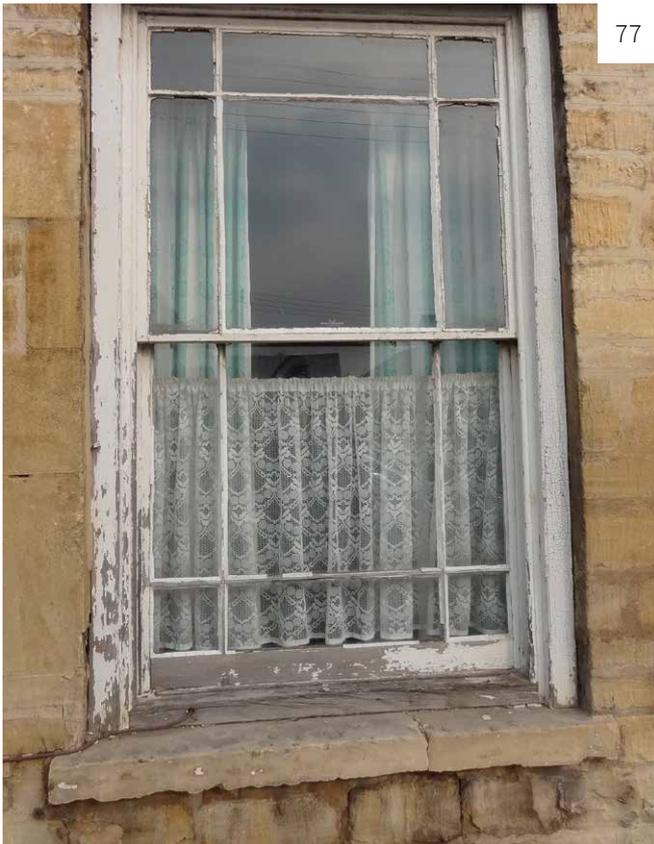
77

77. A double hung sash window lacking maintenance but still easily capable of being overhauled.

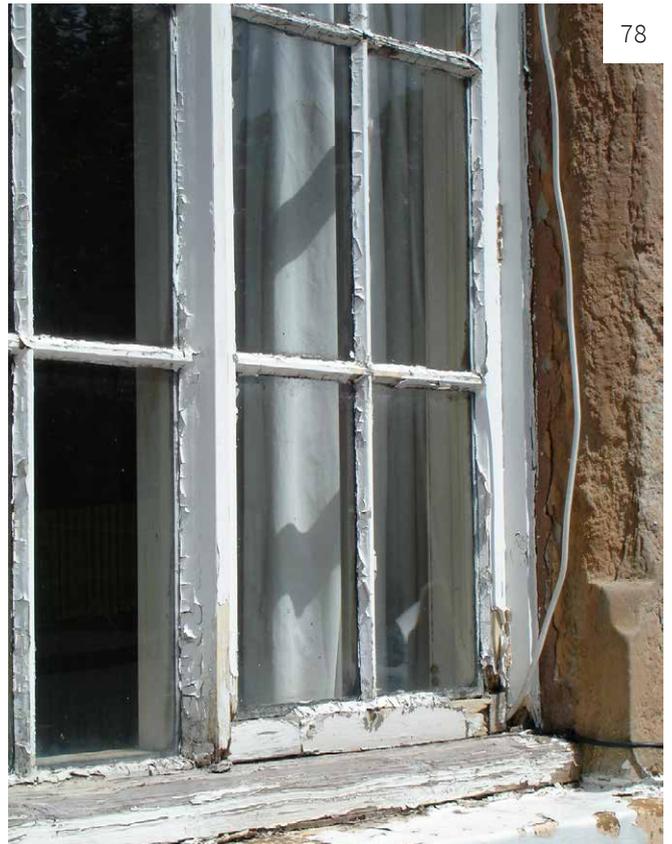
78

78. Lack of maintenance has resulted in lost putties to glazing and rot at the base of the window frames all capable of repair. Cables fed through the base of the frame have allowed water to enter and contribute to the rot.

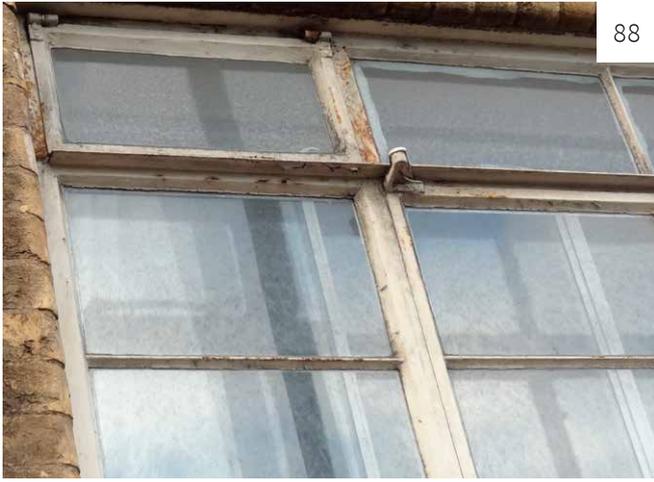
88

88. A steel window showing signs of corrosion with paint blistering.

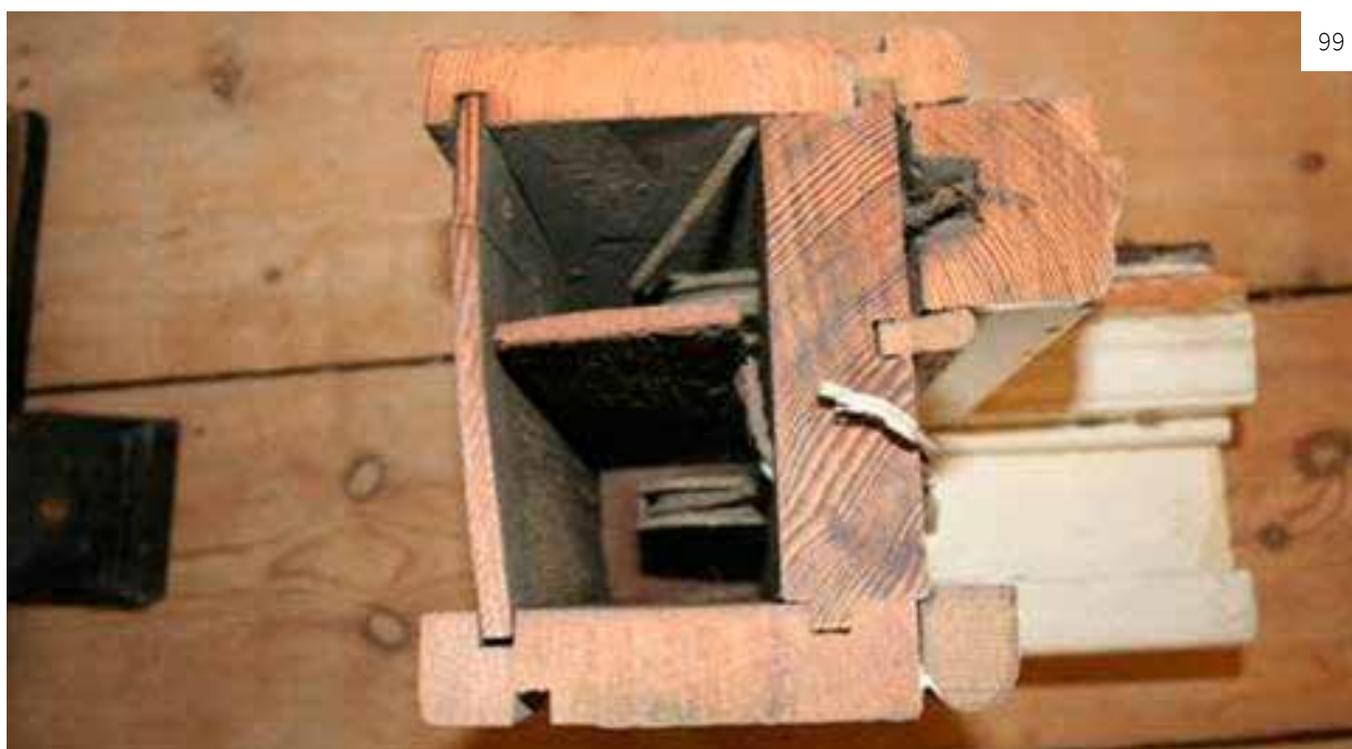
Image 99

This section through a sash box shows the high quality of the timber used during the 19th century.

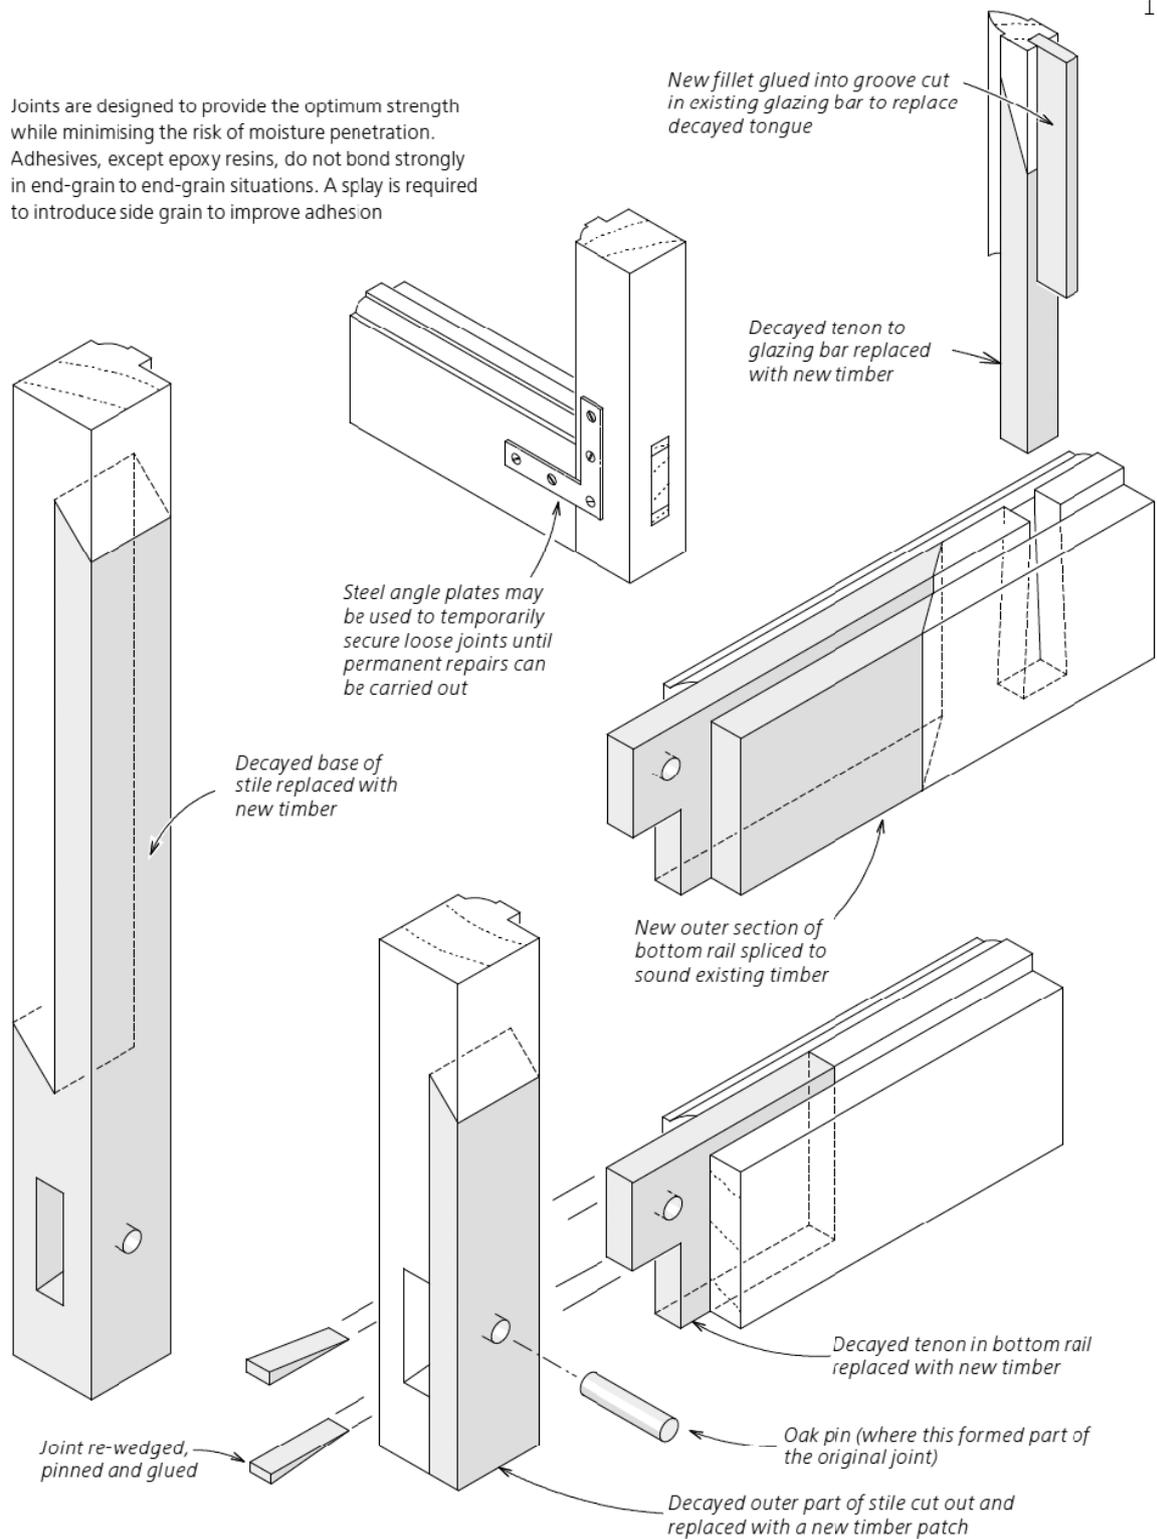
Image 100

Typical timber-to-timber repairs to sash and casement components

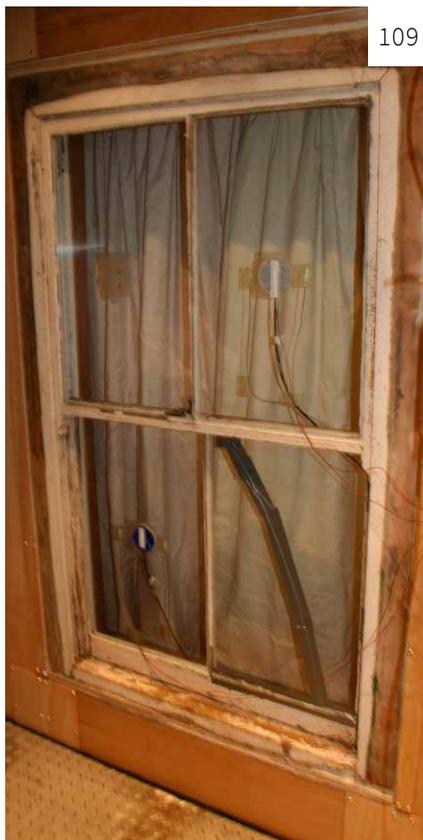
Image 109

Testing windows in the climate chamber at Glasgow Caledonian University.

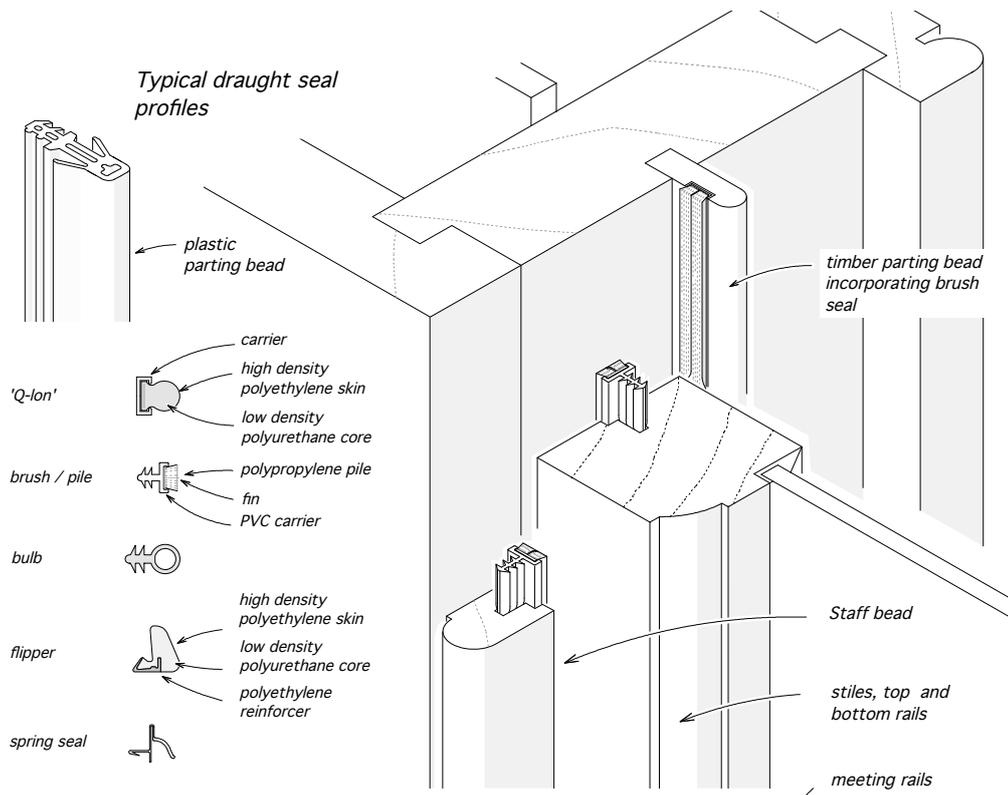
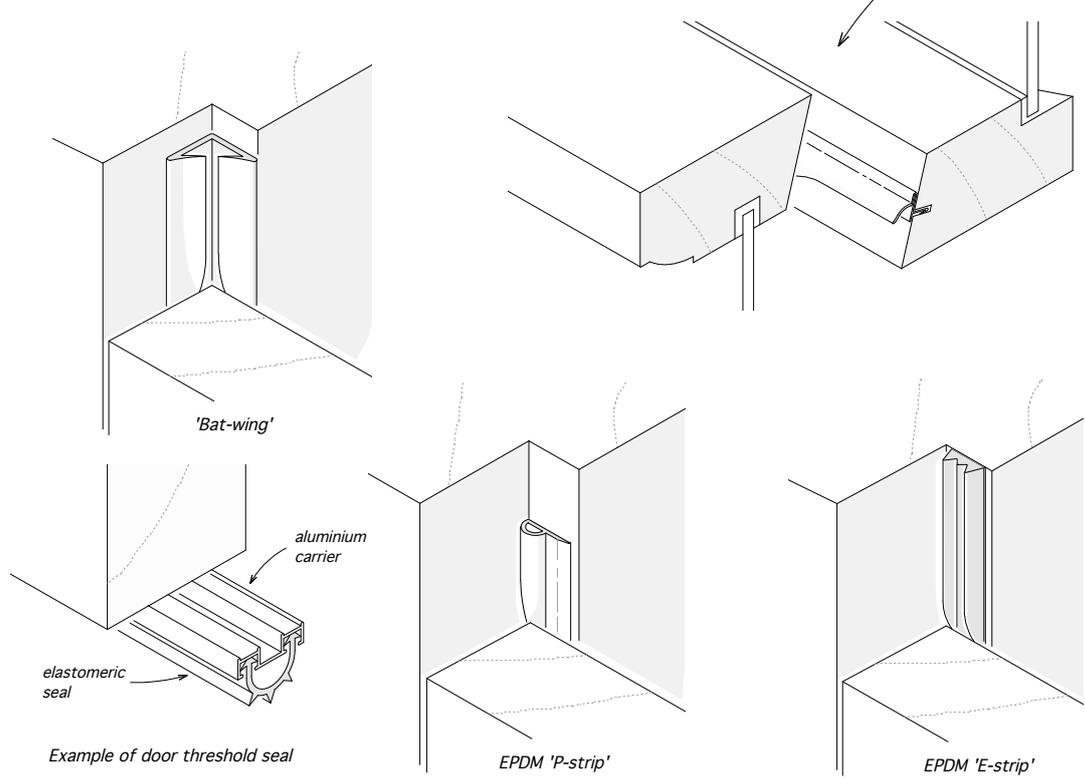
Image 114

- A. Example of draughtproofing for sash windows
- B. Examples of draughtproofing for casements or doors

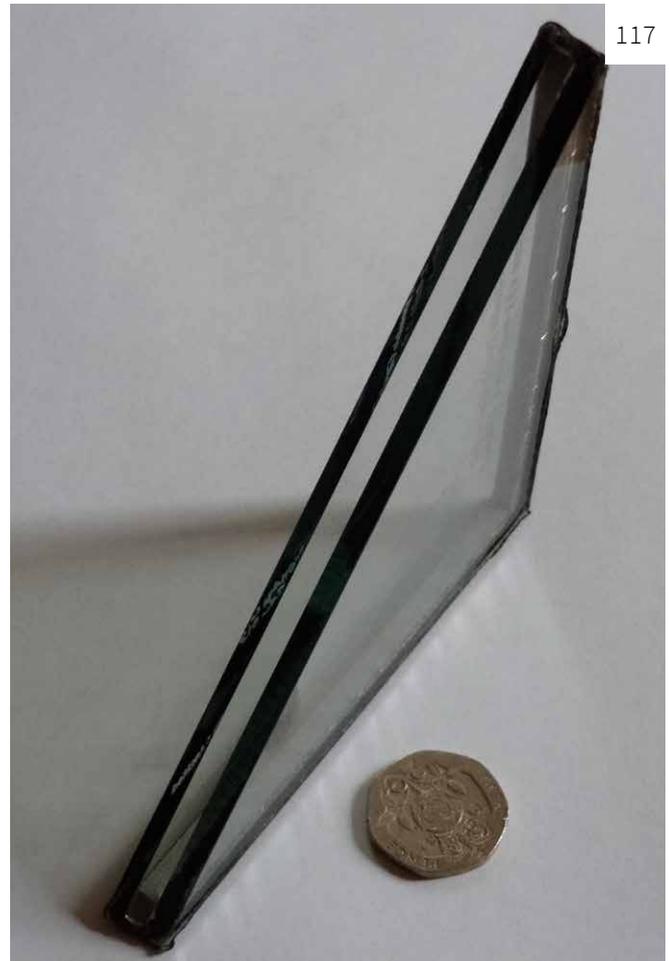
Image 117

This slim profile IGU comprises 3mm outer glazing a 3mm gas filled cavity and 4mm Low-E inner glazing giving a total thickness of 10mm.

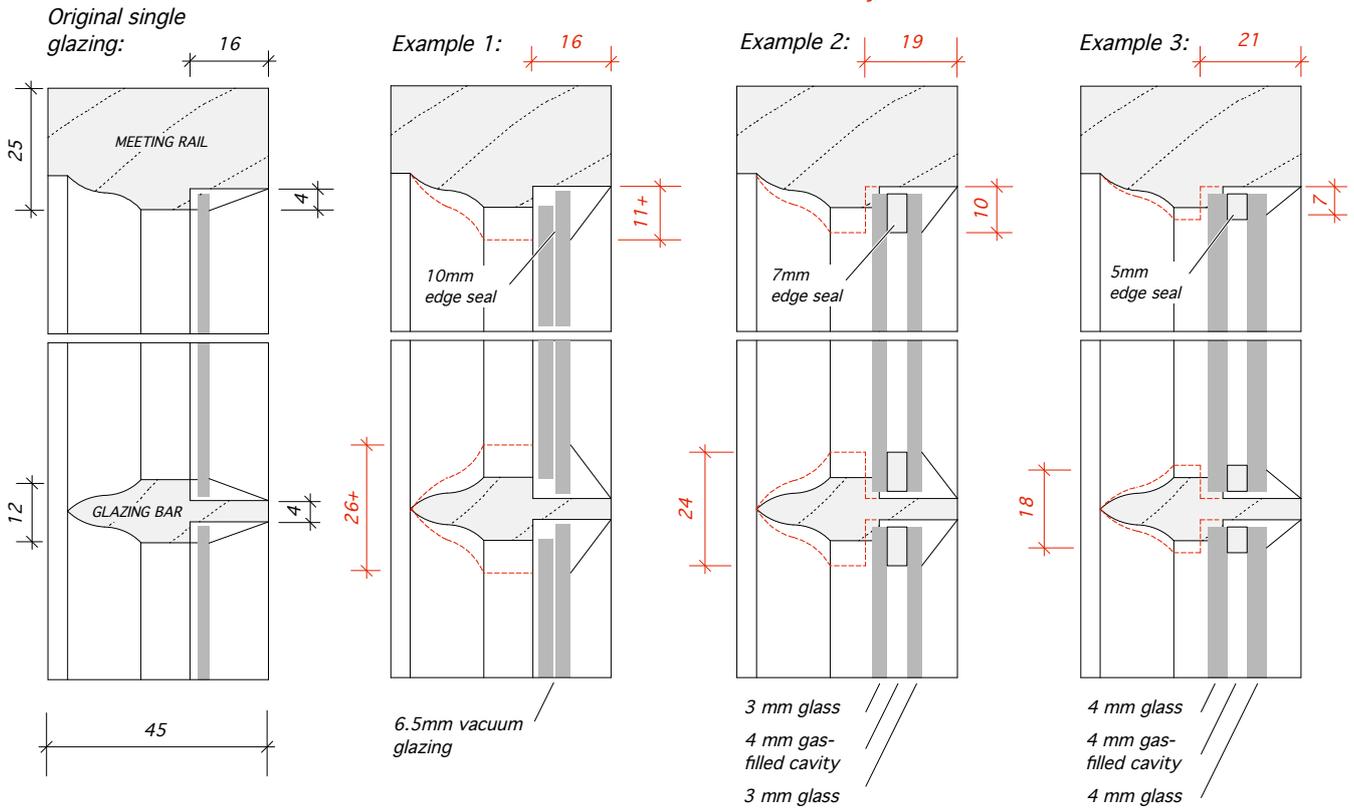
Dimensions in red show the minimum rebate and glazing bar dimensions recommended by the IGU manufacturer.

118. This drawing shows the different thicknesses of insulated glass units currently available when applied to a window with slim glazing bars.

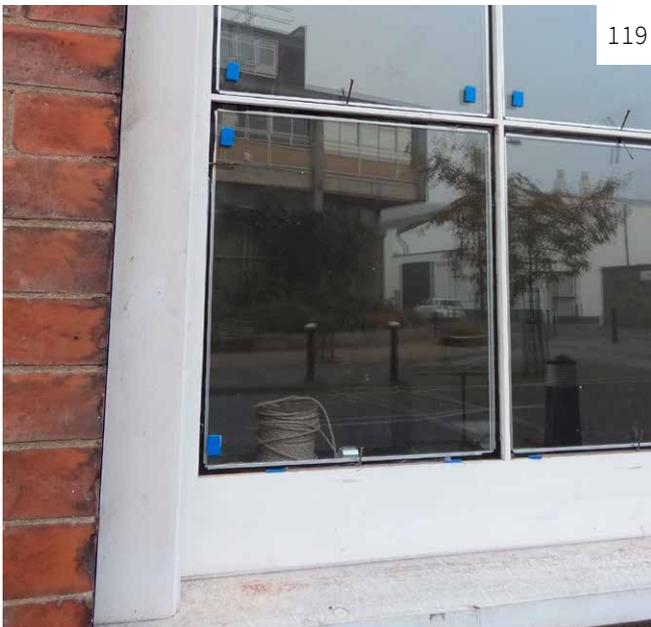
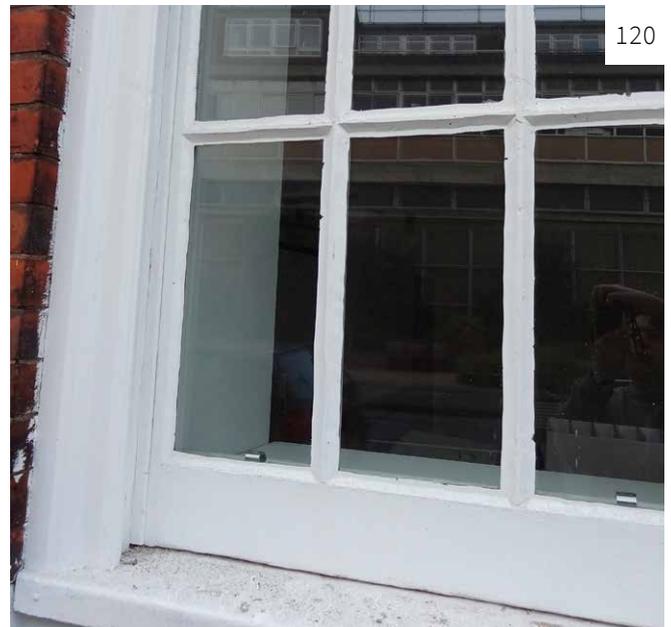
119-120. These existing windows had IGUs fitted but the width of the edge seals necessitated the painting of the glazing bars to be extended over the glass so that the seals are not visible.
